terralab
engineers
international

Analysis No. 16481
Report Date 25 January 1994
Date Sampled Unknown
Where Sampled Unknown
Sampled By Client

This is to certify that we have examined: Roof Decks, Hail Resistance identified: Roof Decks identified: Sierra Shake or Corona Shake, Decra Tile, and Sierra Tile

**NBS Series 23
HAIL RESISTANCE OF ROOFING PRODUCTS**

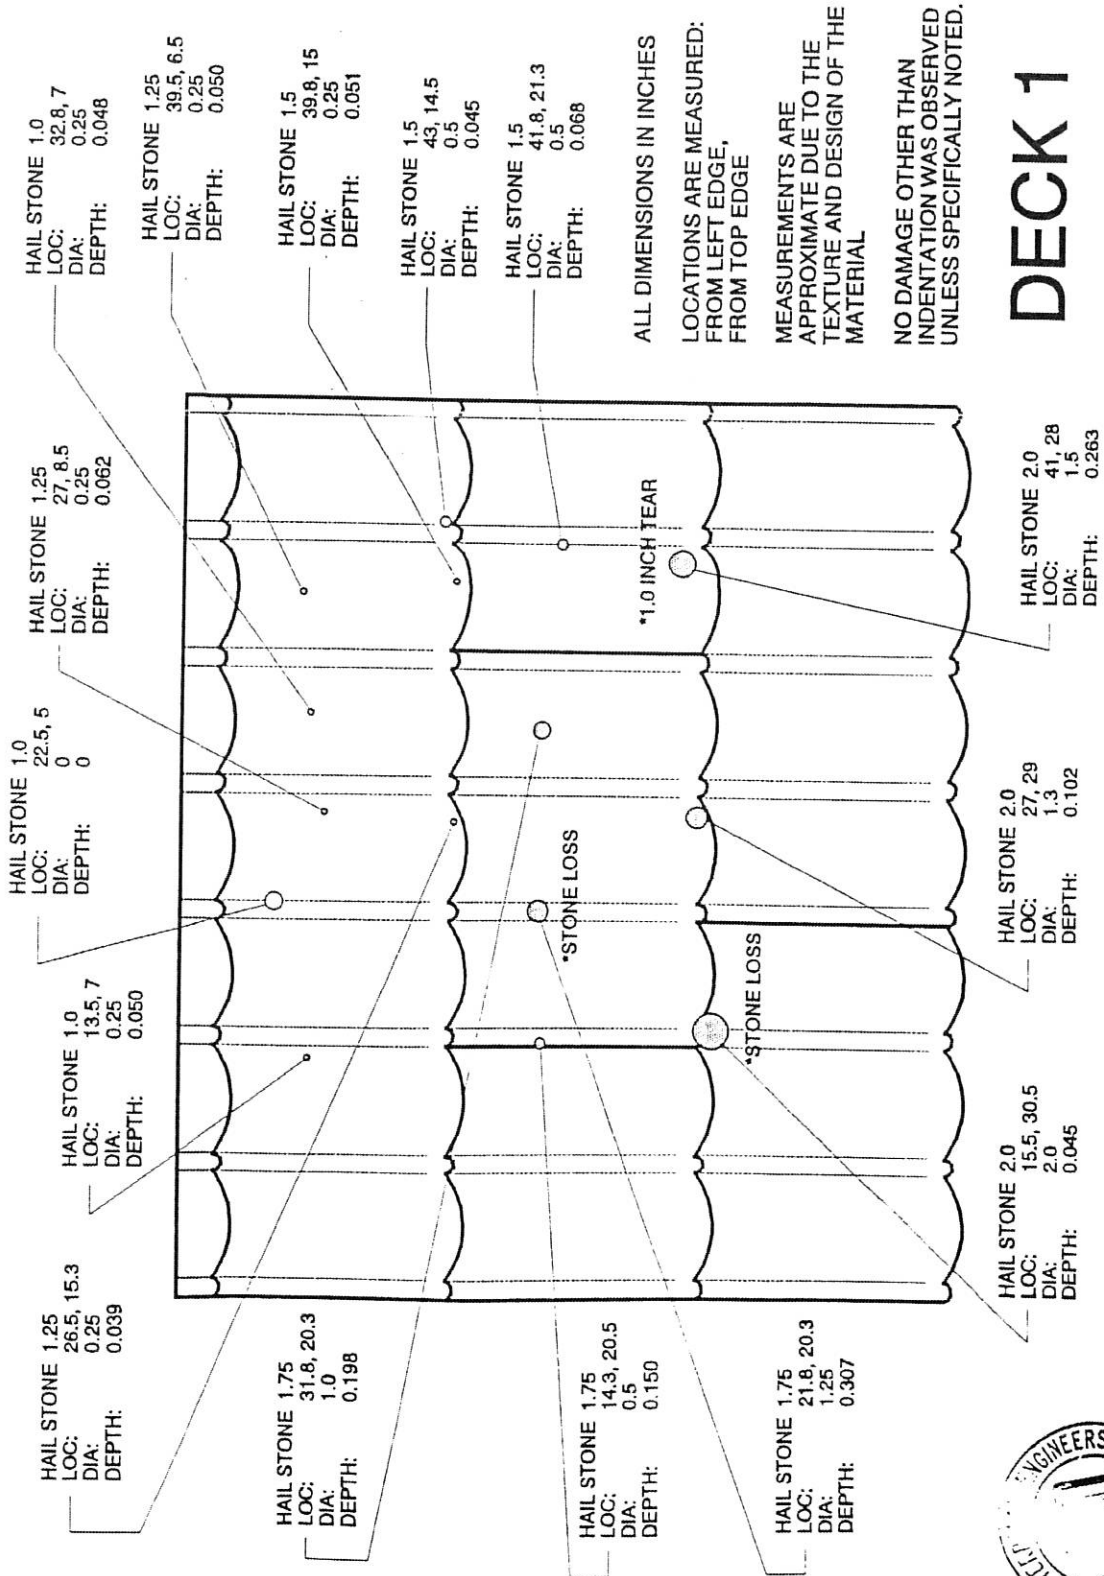
FIGURE 4

ALL DIMENSIONS IN INCHES

LOCATIONS ARE MEASURED:
FROM LEFT EDGE,
FROM TOP EDGE

NO DAMAGE OTHER THAN
INDENTATION WAS OBSERVED
UNLESS SPECIFICALLY NOTED.

DECRA TILE (DECK 1)				
SHOT	HAIL SIZE	LOCATION*	DAMAGE	OBSERVATIONS
1	1.0	22.5, 5	2	No indentation
2	1.0	13.5, 7	2	0.050 deep indentation
3	1.0	32.8, 7	2	0.048 deep indentation
4	1.25	39.5, 6.5	2	0.050 deep indentation
5	1.25	27, 8.5	2	0.062 deep indentation
6	1.25	26.5, 15.3	2	0.039 deep indentation
7	1.5	39.8, 15	2	0.051 deep indentation
8	1.5	43, 14.5	2	0.045 deep indentation
9	1.5	41.8, 21.3	2	0.068 deep indentation
10	1.75	31.8, 20.3	2	0.198 deep indentation
11	1.75	21.8, 20.3	2	0.307 deep indentation, stone chip loss
12	1.75	14.3, 20.5	2	0.150 deep indentation
13	2.0	15.5, 30.5	2	0.045 deep indentation, stone chip loss
14	2.0	27, 29	2	0.102 deep indentation
15	2.0	41, 28	1	0.263 deep indentation, 1.0 tear

* Impact locations are given in inches in the format (A,B) in which A is the distance from the left edge and B is the distance vertically from the top.

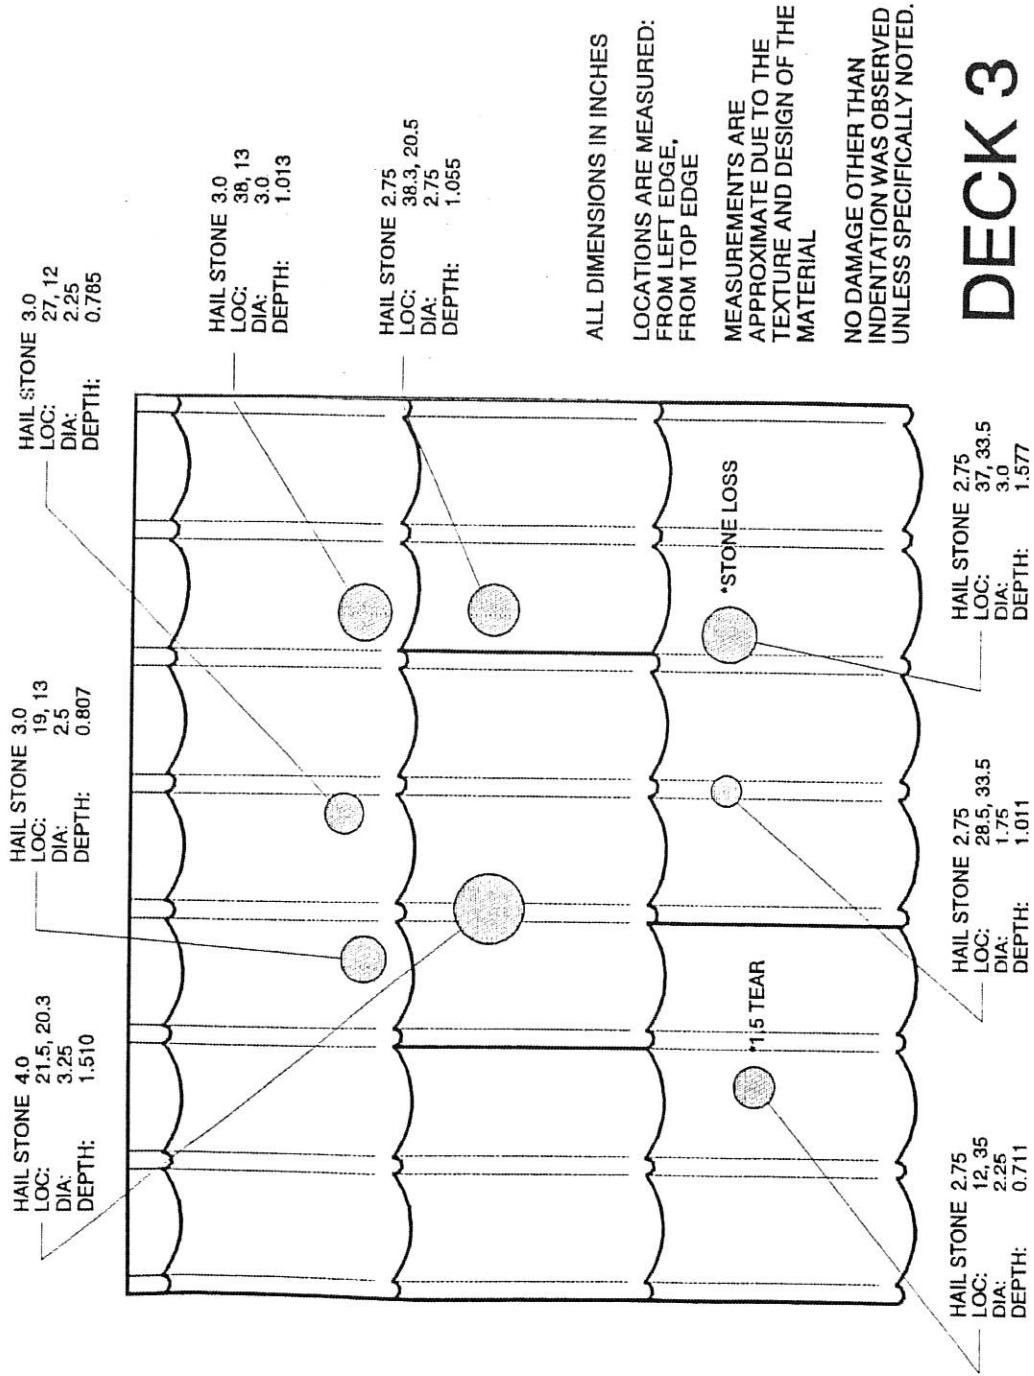
FIGURE 6

ALL DIMENSIONS IN INCHES

LOCATIONS ARE MEASURED:
FROM LEFT EDGE,
FROM TOP EDGE

DECRA TILE (DECK 3)				
SHOT	HAIL SIZE	LOCATION*	DAMAGE	OBSERVATIONS
25	2.75	12, 35	1	0.711 deep indentation, 1.5 inch tear
26	2.75	28.5, 33.5	2	1.011 deep indentation
27	2.75	37, 33.5	2	1.577 deep indentation, stone chip loss
28	2.75	38.3, 20.5	2	1.055 deep indentation
29	3.0	38, 13	2	1.013 deep indentation
30	3.0	27, 12	2	0.785 deep indentation
31	3.0	19, 13	2	0.807 deep indentation
32	4.0	21.5, 20.3	2	1.510 deep indentation
